# Secondary Crash Research

## A Multistate Analysis

*June 2023*

<b>1. Report No.</b> FHWA-HOP-23-043	<b>2. Government Accession No.</b>	<b>3. Recipient's Catalog No.</b>	
<b>4. Title and Subtitle</b> Secondary Crash Research: A Multistate Analysis		<b>5. Report Date</b> June 2023	
		<b>6. Performing Organization Code</b>	
<b>7. Author(s)</b> Kelley Klaver Pecheux, Ph.D.; Grady Carrick, Ph.D.; Benjamin B. Pecheux		<b>8. Performing Organization Report No.</b>	
<b>9. Performing Organization Name and Address</b> AEM Corporation 13880 Dulles Corner Lane, Suite 300 Herndon, VA 20171  Under contract to: Cambridge Systematics 3 Bethesda Metro Center, Suite 310 Bethesda, MD 20814		<b>10. Work Unit No. (TRAIIS)</b>	
		<b>11. Contract or Grant No.</b> DTFH61-16-D-00051	
<b>12. Sponsoring Agency Name and Address</b> U.S. Department of Transportation Federal Highway Administration Office of Operations (HOP) 1200 New Jersey Avenue, SE Washington, DC 20590		<b>13. Type of Report and Period Covered</b> Final Report

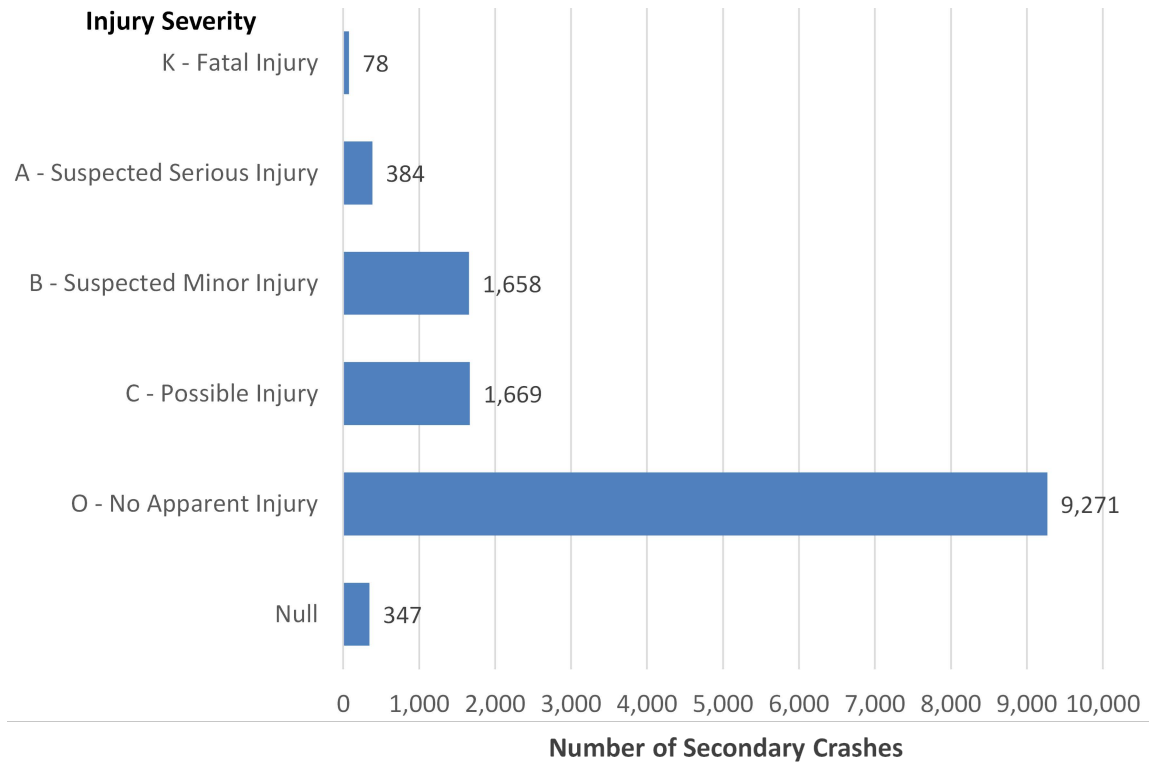
**Figure 6. Bar chart. Number of secondary crashes by injury severity.**

The second general trend observed from the results of the cluster analysis was that, for some of the data elements used in the analysis, the results showed that there were secondary crashes in all three clusters across all the attributes and that the distribution of the secondary crashes across the data attributes within each cluster generally followed the overall distribution of the data. An example is shown in figure 20. This figure shows the cluster analysis results across the injury severity categories (KABCO). Each of the clusters contains secondary crashes for all severity categories, and these distributions generally follow those of the overall (unclustered) data (shown in figure 6).

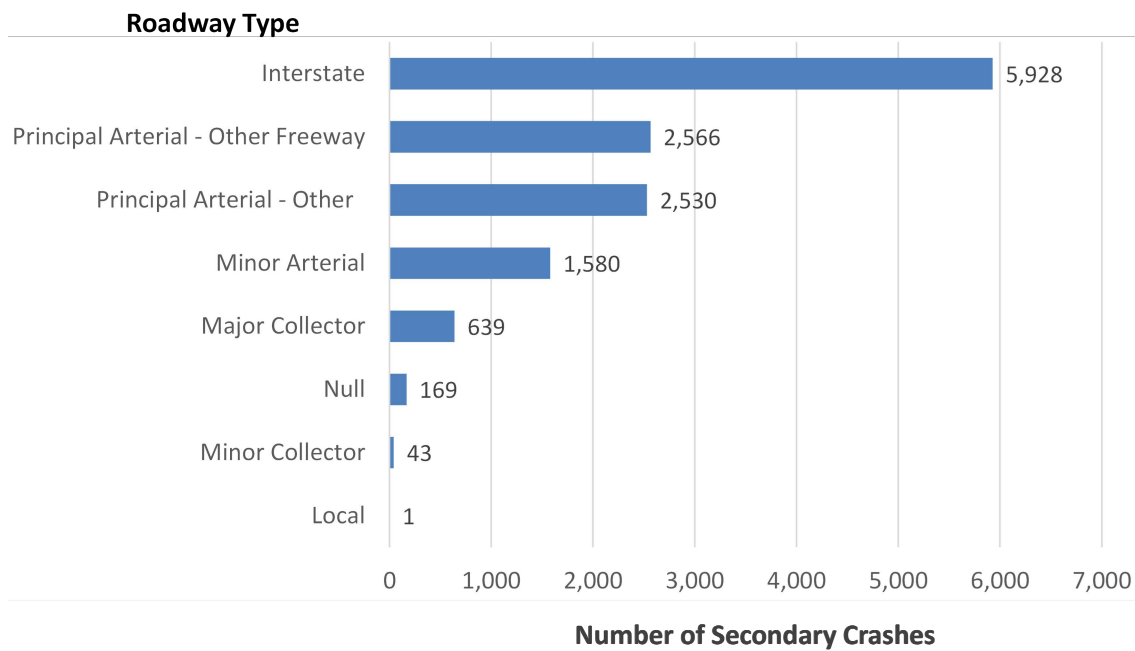
Figure 7 shows the number of verified secondary crashes by roadway type. Nearly 45 percent of the verified secondary crashes occurred on Interstate Highways, while about 38 percent of the verified secondary crashes occurred on principal arterials.

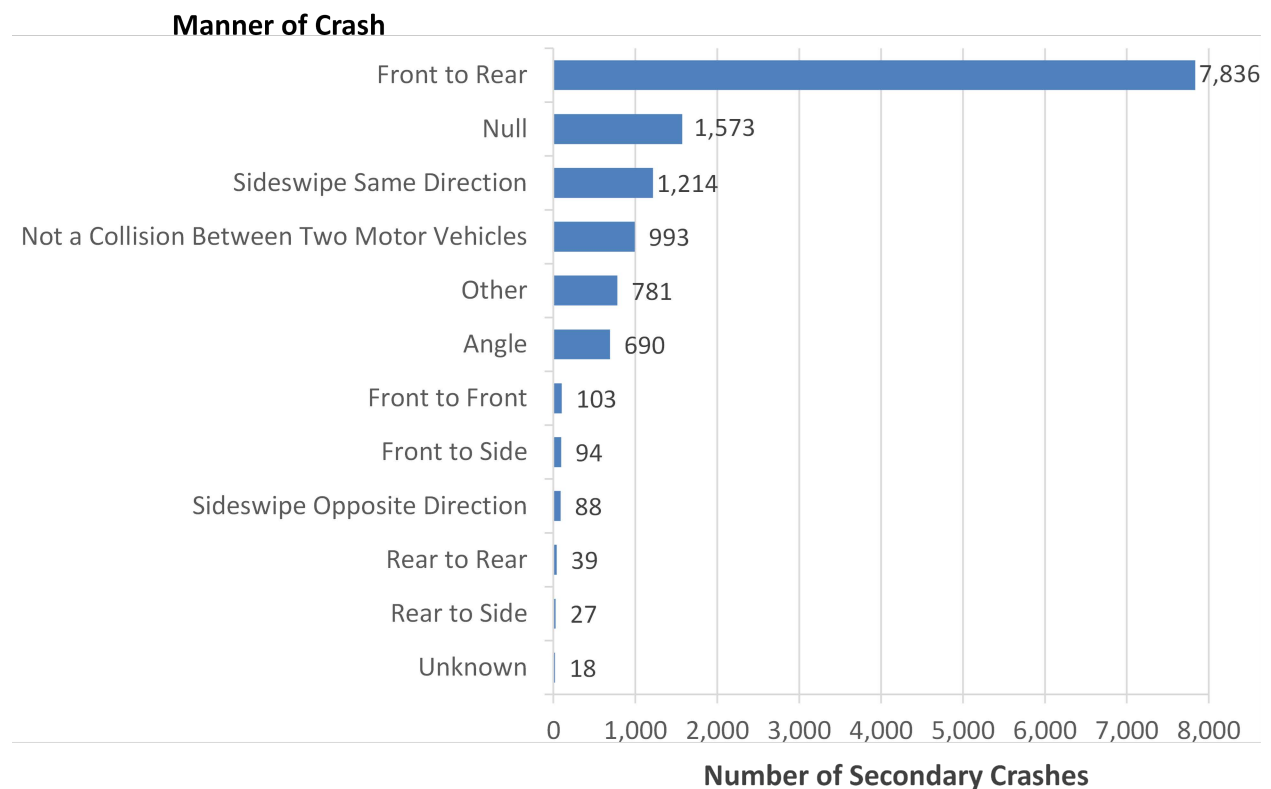
Figure 8 shows the number of verified secondary crashes by manner of crash. Just under 66 percent of the secondary crashes (with known values for manner of crash) were classified as “front to rear,” which makes sense given that many secondary crashes are back-of-queue crashes due to congestion caused by a primary incident. About 10 percent of the verified secondary crashes were classified as “sideswipe same direction,” which also makes sense given that drivers may swerve left or right to avoid striking a stopped or slowing vehicle due to a prior traffic incident. A little more than 8 percent of the secondary crashes were classified as “not a collision between two motor vehicles.” These crashes could involve drivers’ veering off the road to avoid the primary crash or associated traffic queue and striking other objects, striking debris from a prior crash, or even striking a responder at a prior incident. About 8.8 percent of the crashes, however, fall into categories that may bring into question whether they were indeed secondary crashes, including “angle” crashes (5.81 percent), “front-to-front” crashes (0.87 percent), “front-to-side” crashes (0.79 percent), “sideswipe opposite direction” crashes (0.74 percent), “rear-to-rear” crashes (0.33 percent), and “rear-to-side” crashes (0.23 percent). Crashes of these natures could theoretically happen as secondary crashes (e.g., if a primary crash resulted in a vehicle’s being spun around to face the opposite direction of traffic flow, then a secondary crash could involve a “sideswipe-opposite-direction” or a “front-to-front” crash); however, some (e.g., rear to rear or rear to side) seem more unlikely for secondary crashes and may suggest that the crashes were not secondary in nature. A review of the narratives for these crashes could confirm whether they were secondary crashes.

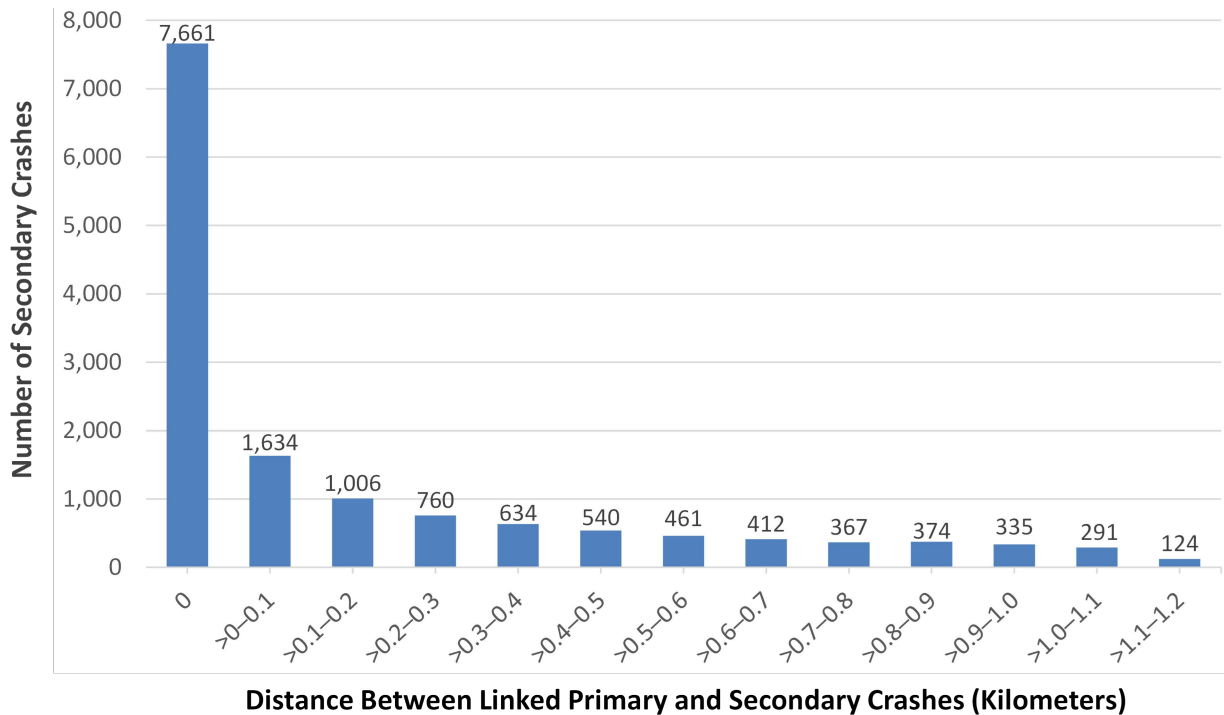
with decreasing numbers of secondary crashes as the distance between the primary and secondary crashes increased. About 84 percent of secondary crashes reportedly occurred within a half kilometer of the primary crashes.

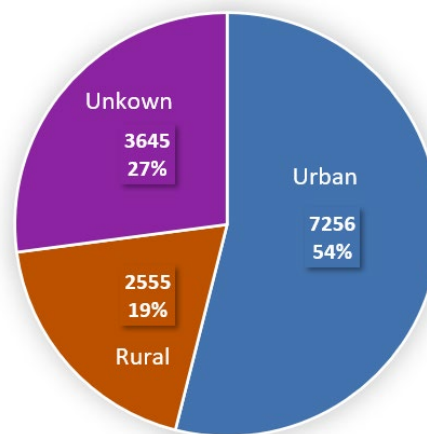
Figure 11 shows the numbers and percentages of verified secondary crashes by whether they occurred in an urban, rural, or unknown area. Most of the secondary crashes (54 percent) occurred in urban areas, and 19 percent occurred in rural areas. For more than a quarter of the verified secondary crashes (27 percent), the rural or urban attribute was missing.

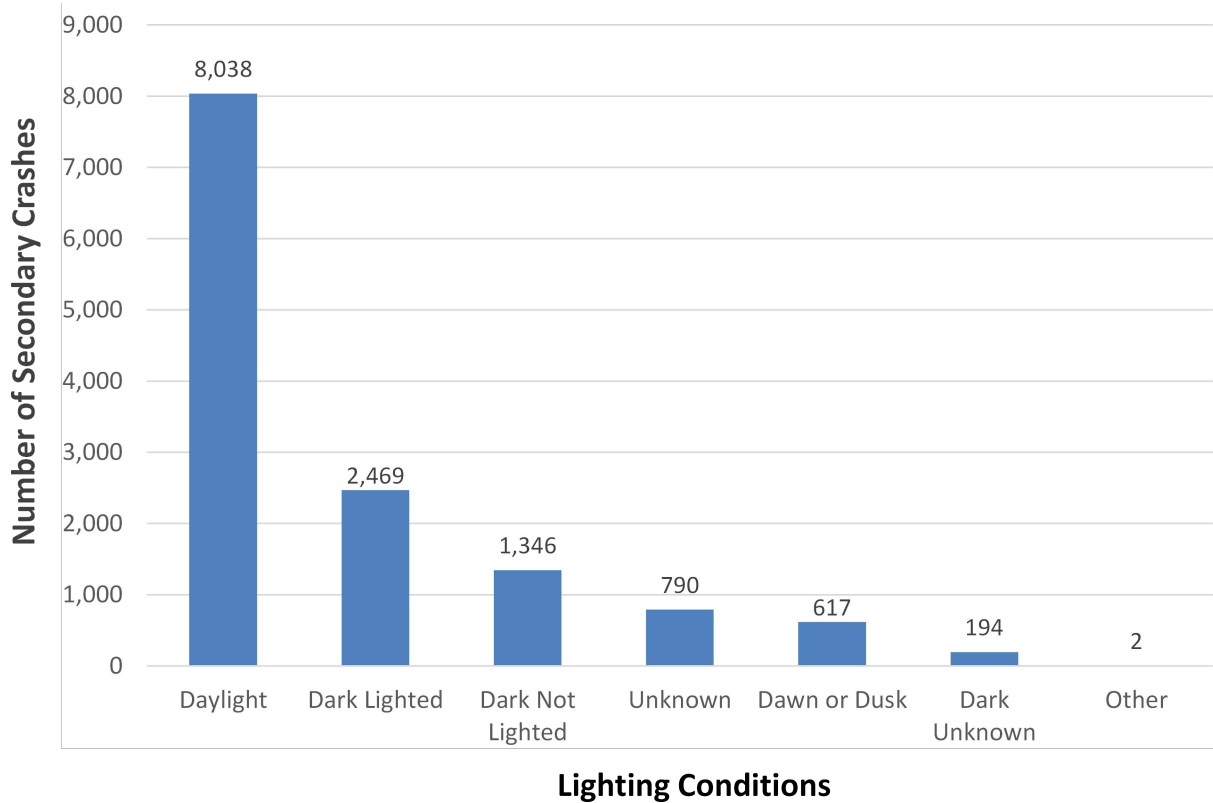
Figure 12 shows the number of verified secondary crashes by lighting conditions. Nearly 60 percent of the secondary crashes occurred in daylight conditions. Another 18 percent occurred in dark but lighted conditions. About 11 percent of the secondary crashes occurred in dark conditions. And less than 5 percent occurred around dawn or dusk.

**Figure 12. Bar chart. Number of secondary crashes by lighting conditions.**

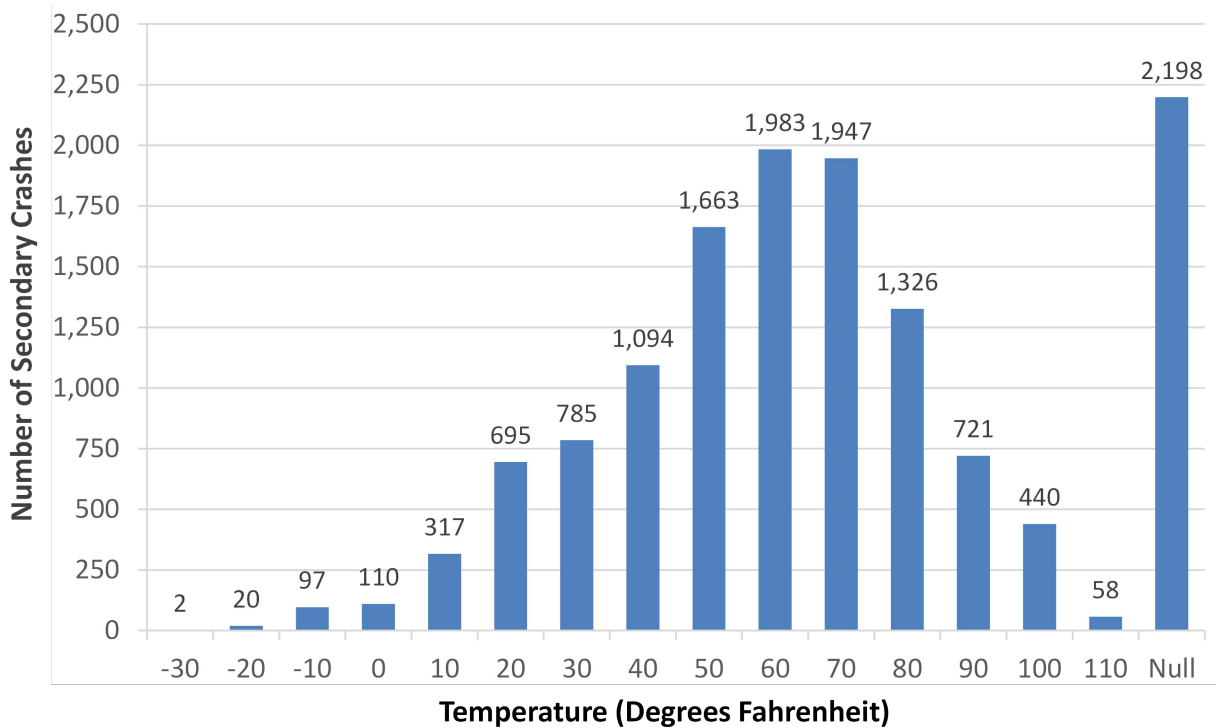
Figure 14 shows the number of verified secondary crashes by atmospheric temperature. The graph shows a bell-shaped distribution around an average of about 60 degrees Fahrenheit. While most of the secondary crashes occurred during fair temperatures, the longer tail to the left indicates that slightly more secondary crashes occurred in colder weather conditions compared with hotter weather conditions.

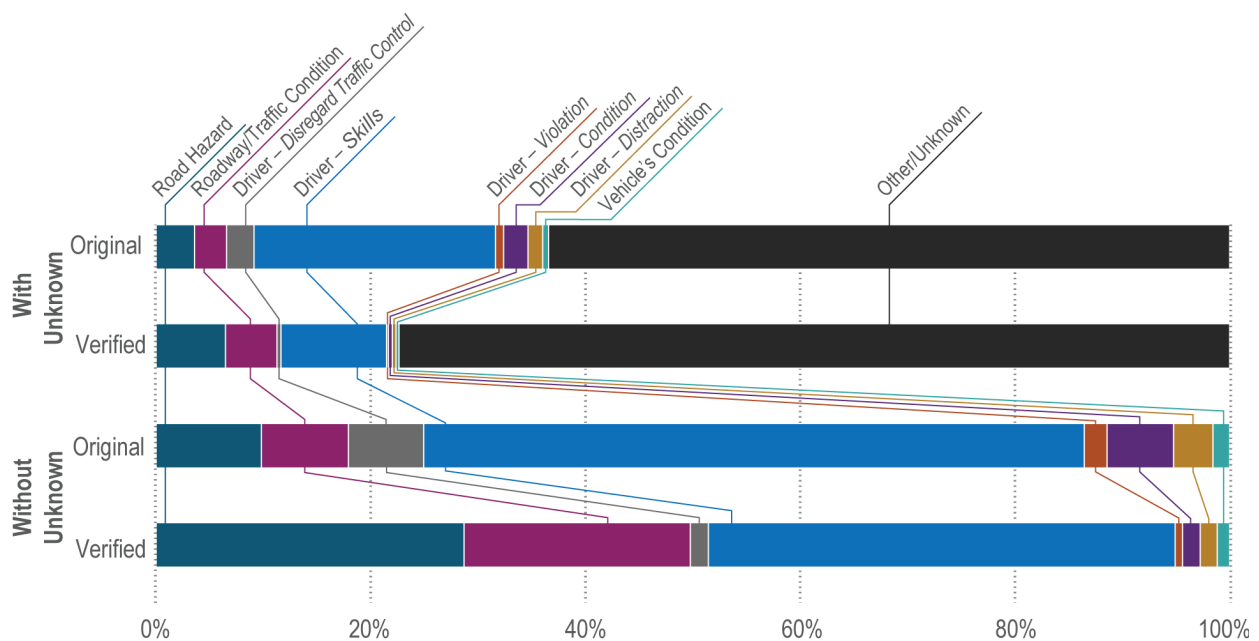
Similarly, a comparison of secondary crash contributing circumstances between the original and verified datasets and with and without unknown data attributes is shown in figure 18. The top two bars show that a large portion of the secondary crashes in both the original and the verified datasets had unknown or missing values for contributing circumstances (about 63 percent and 77 percent, respectively). When the unknown values are removed in the bottom two bars, it can be observed that for most of the secondary crashes (62 percent), driver skills were a contributing factor, while all other factors contributed to less than 10 percent of the secondary crashes. In the verified dataset, on the other hand, “road hazard” and “roadway/traffic condition” contributed to 29 percent and 21 percent of the secondary crashes, respectively, in addition to about 43 percent of secondary crashes with driver skills as a contributing factor. These findings also align with expectations: secondary crashes occur as results of primary incidents, which cause road hazards and roadway/traffic conditions.

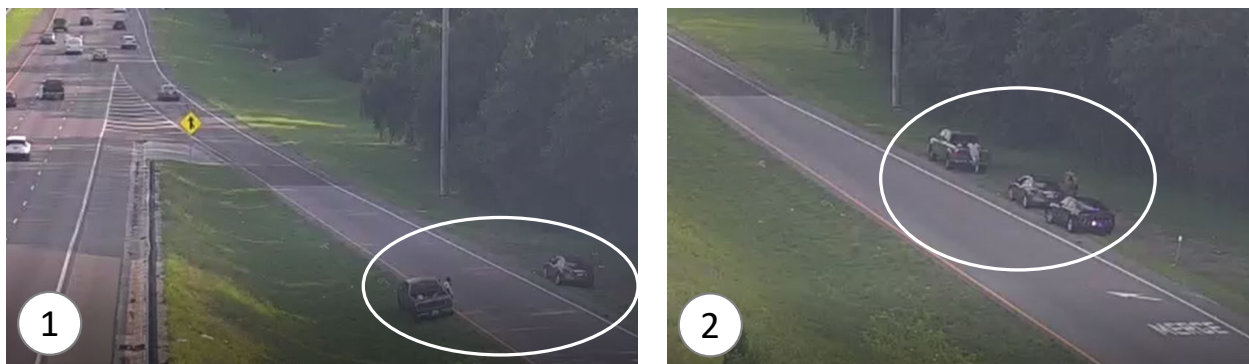
Around 8:37 a.m. a law enforcement officer arrived on the scene and resolved the “split scene” (i.e., crash-involved vehicles stopped so that vehicles must pass between them) by directing the driver of the Tundra to move to the right shoulder. The officer parked his vehicle on the right shoulder behind the two vehicles involved in the crash and continued to use emergency lights to provide advance warning for approaching drivers (figure 21, image 2).

**Figure 21. Photograph. Images from Florida Department of Transportation camera—primary crash.**

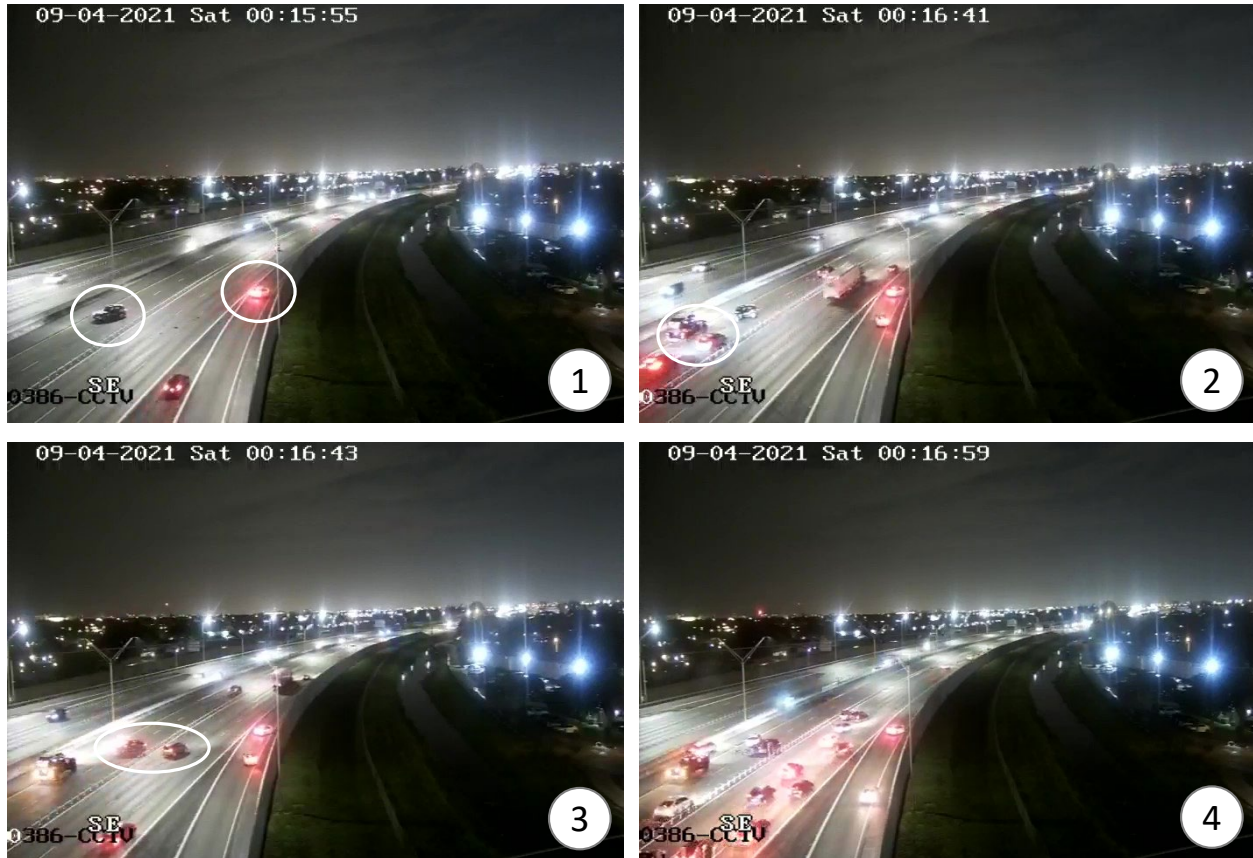
Approximately 2 minutes after the primary crash, a Ford pickup truck and a Chevrolet Equinox were stopped for the disabled Infinity, side by side, in the two express lanes (figure 23, image 2). Another vehicle stopped on the inside shoulder next to the pickup truck. A Land Rover Range Rover, visible in image 2 with brake lights, failed to slow down and struck the Equinox in the right express lane. This secondary crash sent the Equinox into the general-purpose lanes, while

the Range Rover continued forward, striking the disabled Infinity (another secondary crash) involved in the primary crash (figure 23, image 3). These vehicles came to a final rest in the express lane and the inside general-purpose lane, causing approaching traffic to slow and stop (figure 23, image 4).

**Figure 23. Photograph. Images from Florida Department of Transportation camera—secondary crash types 1 and 2.**

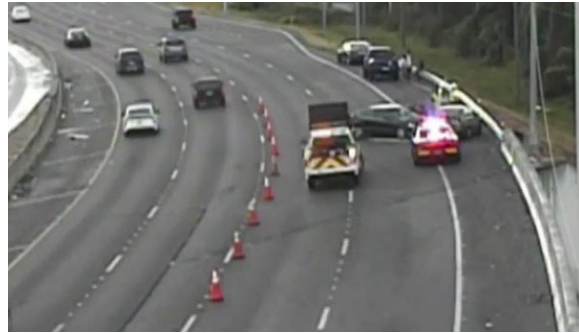
**Figure 31. Photograph. Image from Florida Department of Transportation camera—primary and secondary crash No. 1.**

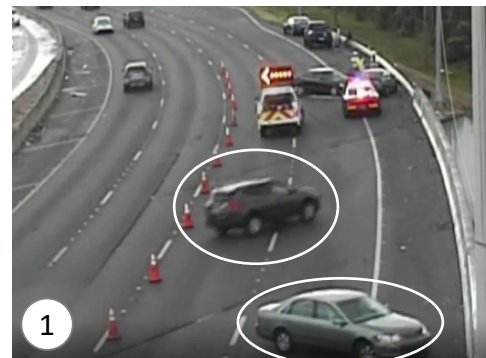
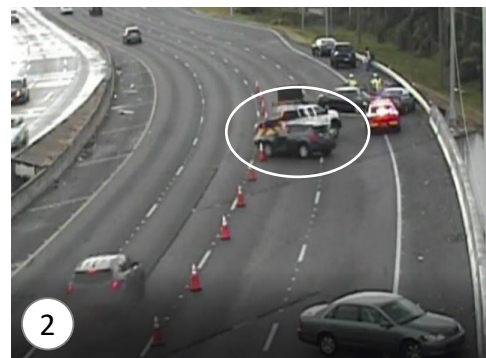
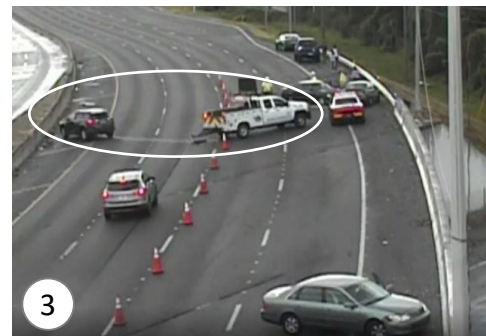
**Figure 32. Photograph. Images from Florida Department of Transportation camera—secondary crash No. 2 (types 3, 5, and 6).**
